Public school building • multi-level low-slope roof

COMMERCIAL LOW-SLOPE ROOF TAKEOFF

SITE  
Durham, North Carolina  
Public elementary school  
Public data only

REPORT ID  
OA-S-0001

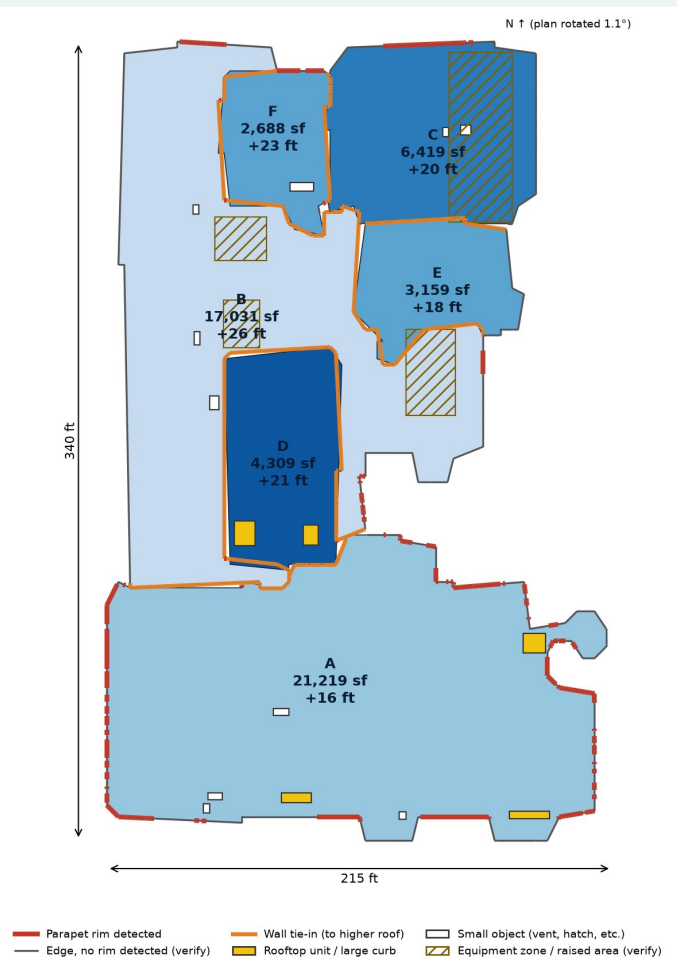
## SECTION MAP • PLAN ROTATED TO BUILDING AXIS

**Summary.** Six low-slope roof sections totalling about **54,825 sf (548 squares)**, traced from 2015 statewide LiDAR and checked against 13 aerials from 2002-2025. The LiDAR outline still matches the 2025 imagery: no additions or removals since 2015. Section A (south classroom wing) is crowned and drains to its north and south edges; the other sections read close to flat, so internal drains are likely (not visible from above). Section A changed from a dark surface (2017) to a white surface (2021), which suggests a re-roof or coating in that window.

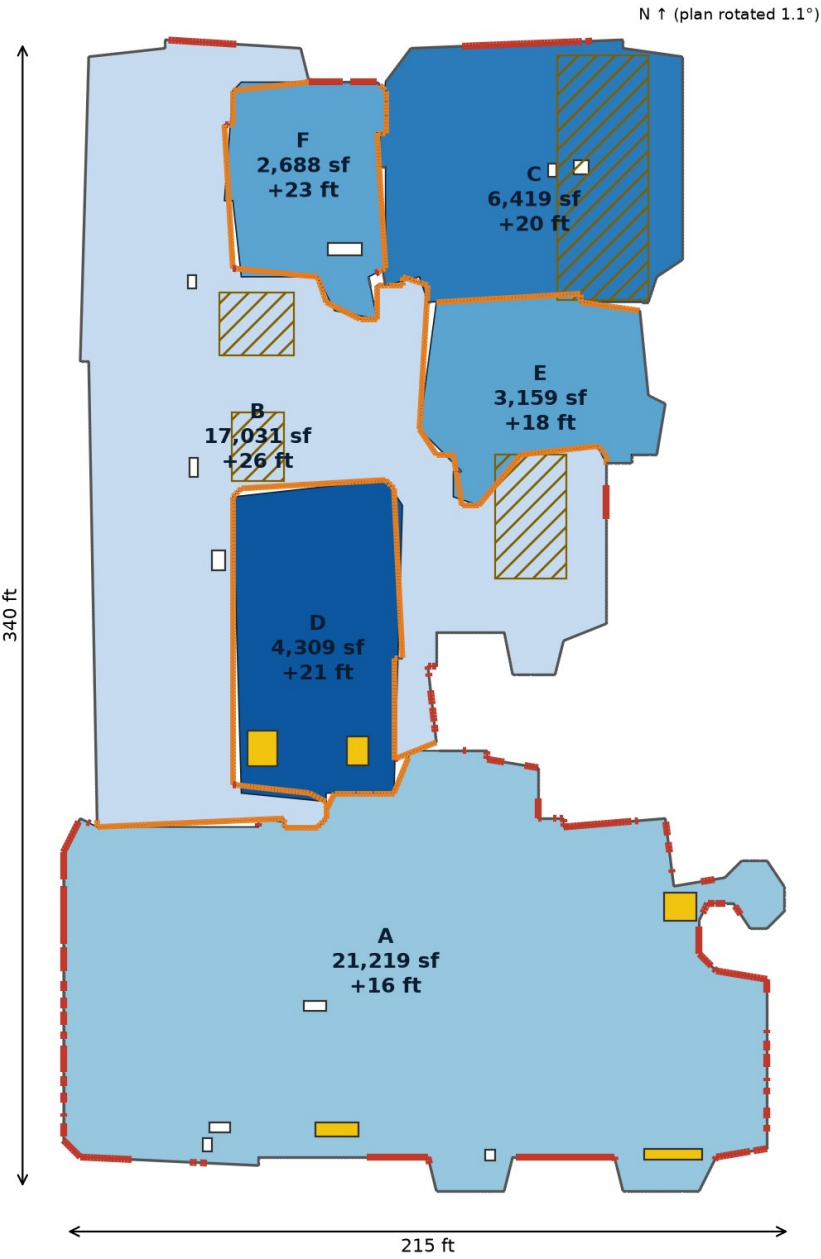
Each fill is one roof level (darker = higher). Labels give the field area and the roof height above adjacent grade. Red edges are where LiDAR shows a parapet rim rising above the roof field; grey edges had no rim returns and may be open edges (gravel stop / drip edge) or low parapets that QL2 LiDAR missed. Orange lines are wall tie-ins where a roof meets a higher wall. Parapet rims where detected read **1.6-2.0 ft** (middle 50%) above the roof field. QL2 LiDAR tends to read narrow copings low, so treat these as minimums.

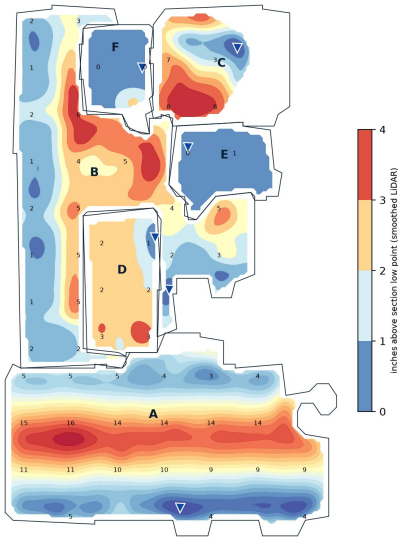
SLOPE-TO-DRAIN MAP (SMOOTHED LiDAR ROOF SURFACE)

Roof-field LiDAR returns for each section, smoothed and shown as inches above that section's lowest point. Triangles mark each section's lowest area. Numbers are spot elevations on a 30 ft grid (inches above the section low point) and can serve as a starting grid for a tapered insulation layout.

**A** has a clear crown along its long axis, about 14-16 in above its north and south edges over ~60 ft (~1/4 in/ft). That fits a roof sloped to edge gutters or scuppers on both long sides.

**B, D, E, F** vary by 1-7 in across the section, which is close to the LiDAR noise for this data. These are likely dead-flat or slightly sloped to interior drains. Expect ponding risk; plan crickets and tapered insulation from a field survey.

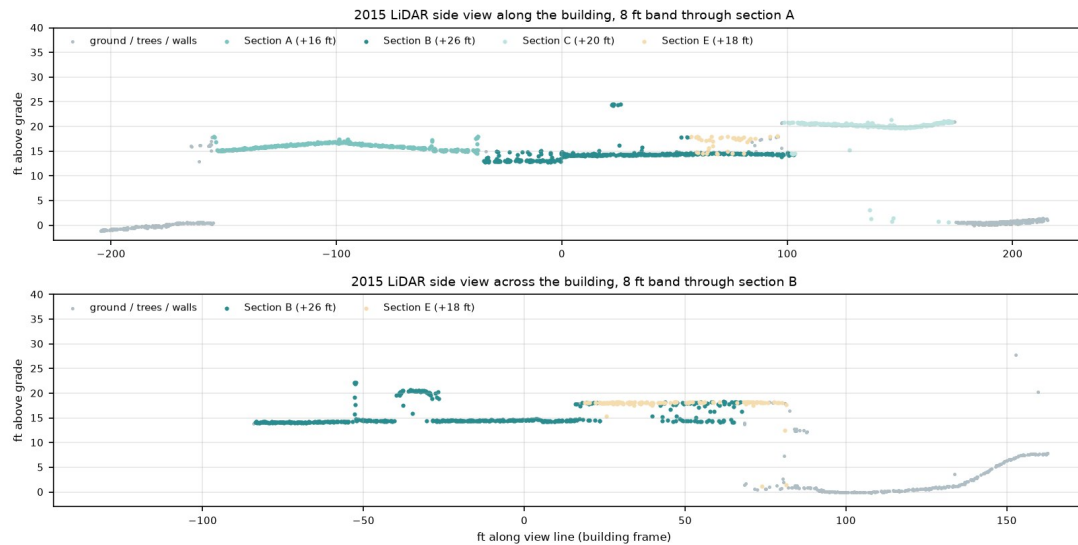
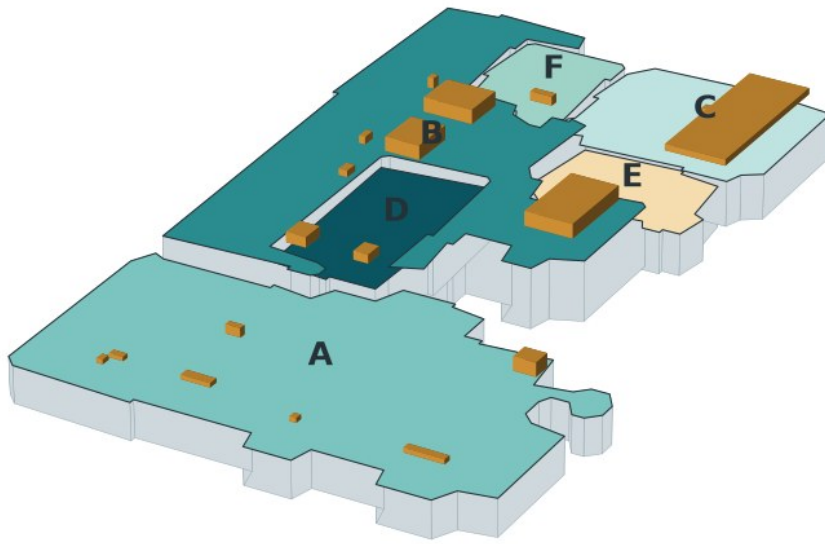
2015 NC LiDAR side views through the building, and a 3D block model of the same data

Heights are roof field (plane fit) minus the median ground return around each section; elevations are NAVD88 ft. The block model extrudes each traced section to its height; rooftop objects are shown in gold. Rises between levels are the wall tie-in heights on OA-04.

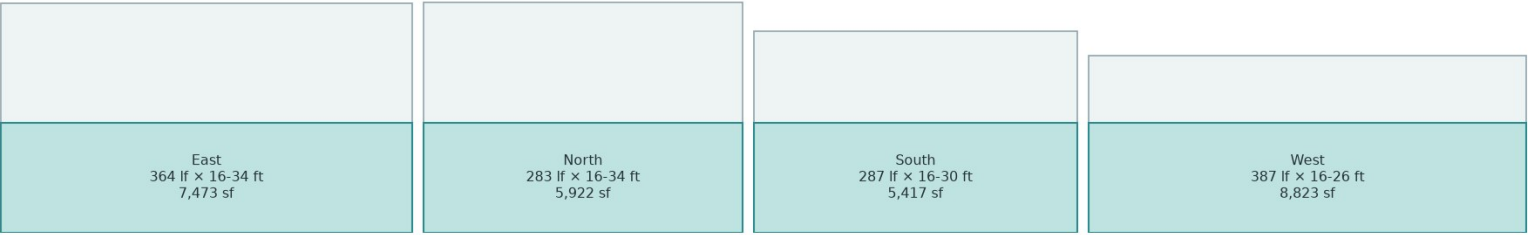
Outer face, grade to roof edge (parapet top where detected) • LiDAR heights

Walls were walked around the LiDAR roof outline at 1 ft steps (same method as the low-slope workflow). Height = roof field (plus parapet rim where detected) minus the median ground return around each section; the site slopes, so grade runs 325-338 ft. Upper walls where a low roof meets a higher wall add 3,642 sf over 752 lf. Confidence Medium (±8%).

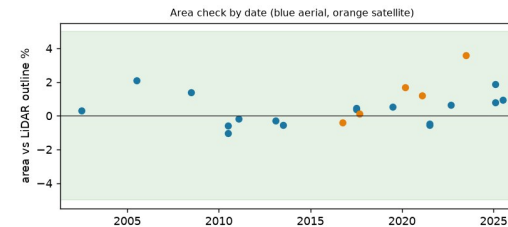
## How it is checked

Each image is shifted to best match the brightness step along the LiDAR outline, then every edge 10 ft or longer is re-traced at the strongest step within  $\pm 5$  ft. Weak edges stay unresolved. Area  $\Delta$  compares the re-traced outline with the LiDAR outline. Leaning satellite captures are kept out of the agreement range.

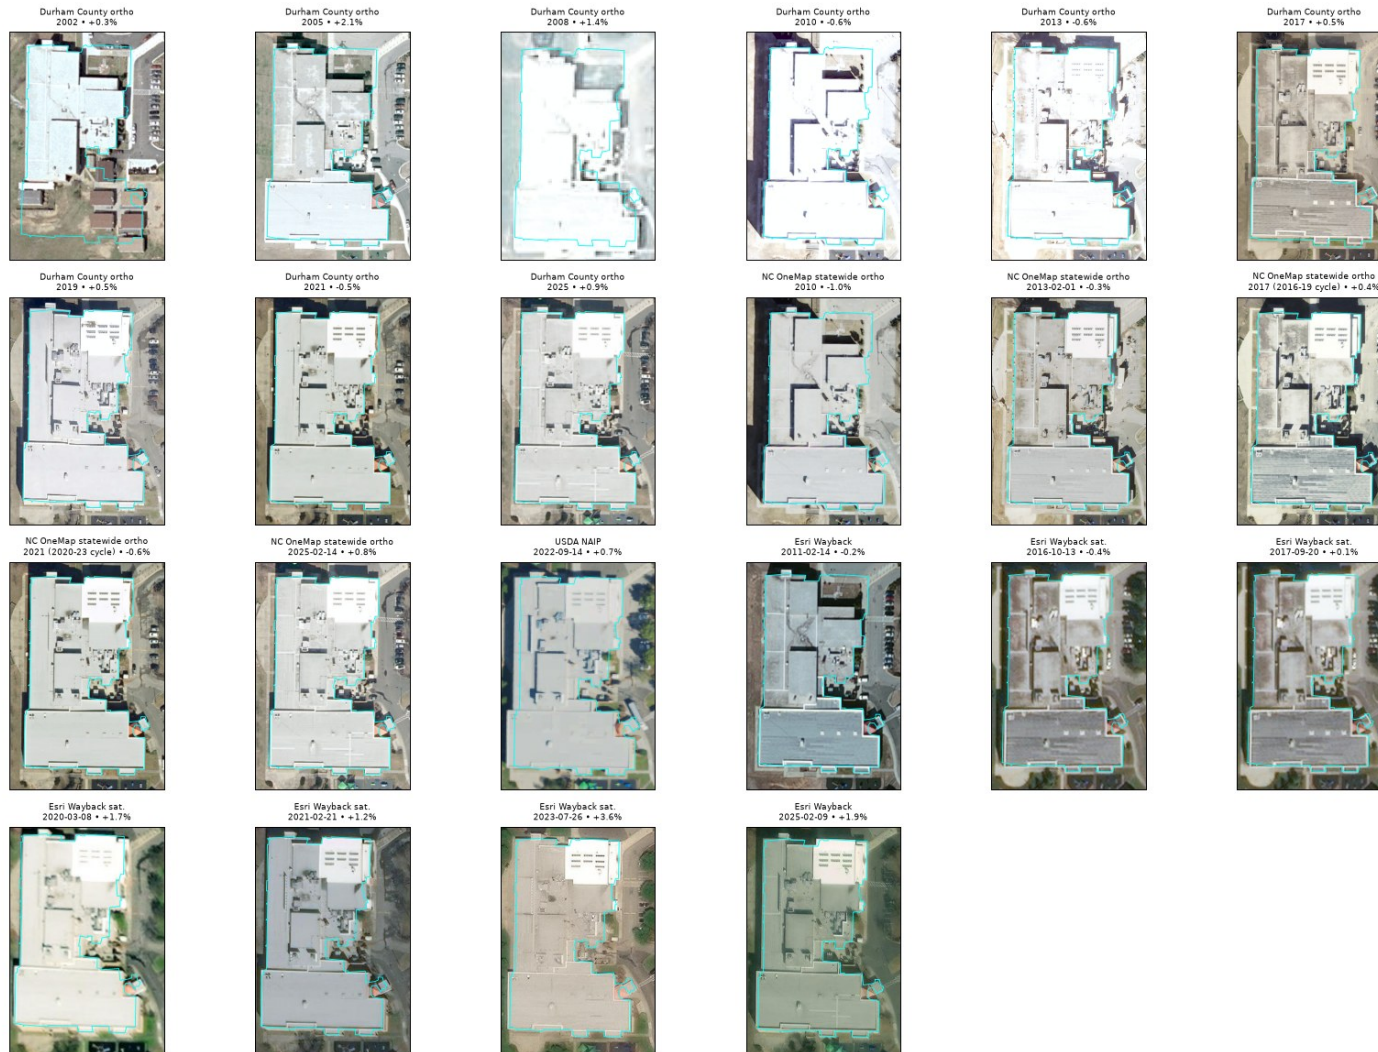
Same roof, every image date • cyan = LiDAR outline shifted onto each image

**Building outline:** the building is present in every image from 2002 to 2025, and the LiDAR outline fits each one. No additions or demolitions found.

**Section A** reads dark grey in 2017 and white in 2021 and 2025. That suggests a re-roof or reflective coating between 2017 and 2021. Ask the owner for records before relying on it.
