# Roof at a Glance

2-story single-family house, built 2001 • cross-hipped / gabled shingle roof

ROOF & WALL MEASUREMENT

OA-S-0003

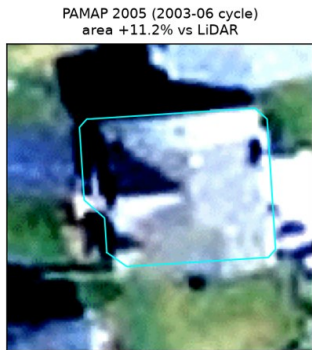
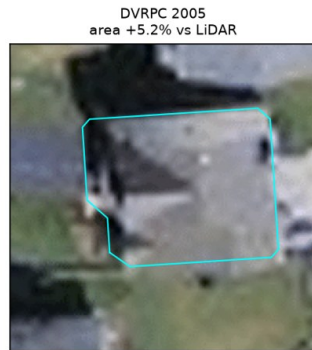
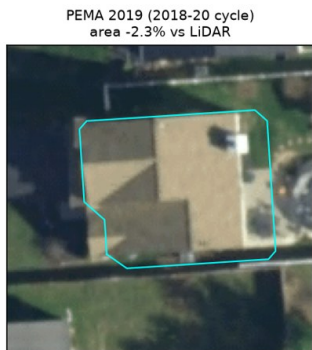
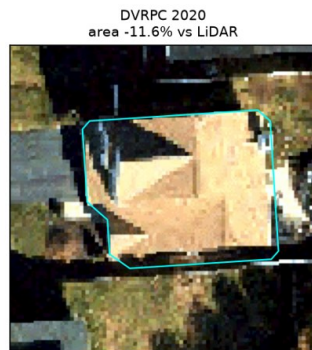
# Imagery Change Review

Same roof, every image date • outline overlaid on each image

**Change review:** the 2000 regional aerial shows no finished house on the lot (county record: built 2001). From 2005 to 2025 the house outline is the same in every aerial; no additions or demolitions found.

The roof reads dark grey in 2005 and 2010 and lighter in 2015 and later. That could be a re-roof between 2010 and 2015, but lighting and sensor differences could also explain it, so it is not confirmed and no roof age is stated.
